CASE REPORT(S): UNCOMPLICATED CROWN FRACTURES

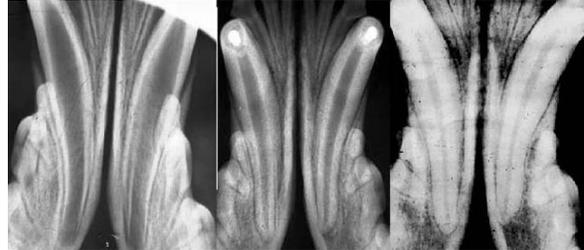
The lower canines of a German short haired pointer at 6, 14 and 32 months of age. Note how the pulp chambers got smaller and the walls of the tooth grew thicker over time.

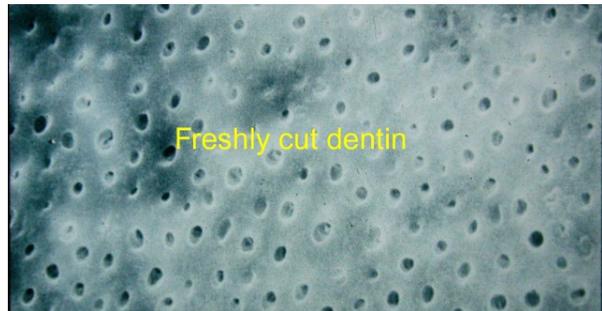
Freshly cut dentin surface showing the open dentin tubules. While these pores are very small, they are larger than bacteria and so can act as open pathways for bacteria to gain entry to the pulp chamber inside the tooth.

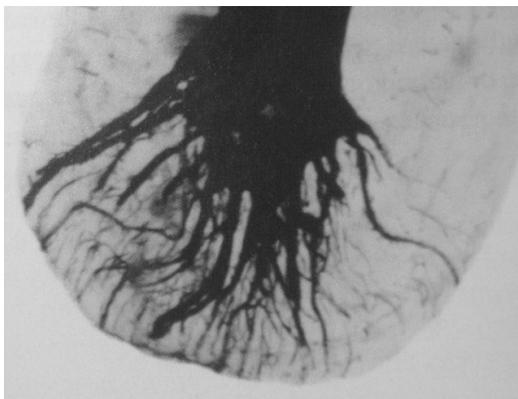
An apical delta stained with India ink. These delta channels are too small to be seen radiographically.

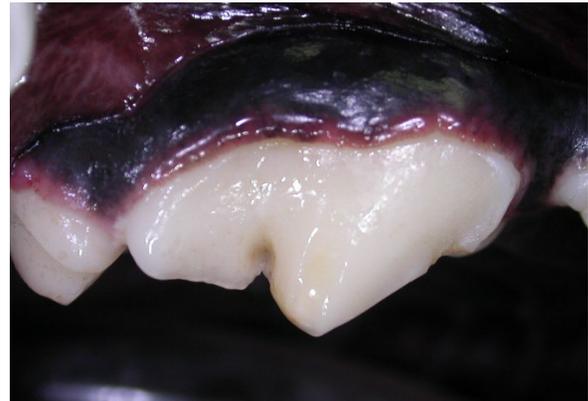
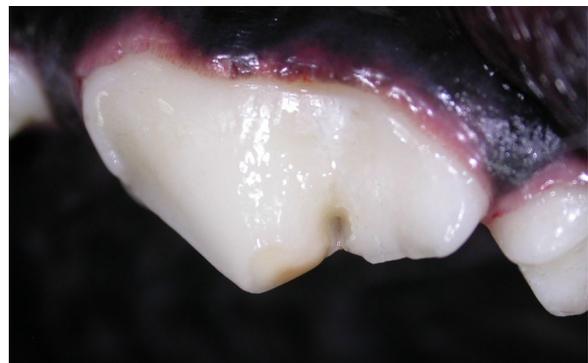
I first saw Breeze in October of 2008 (just over four years of age) for assessment of uncomplicated crown fractures of the right and left upper 4th premolar teeth.

These were quite superficial fractures, but I have seen such damage result in septic pulp necrosis as shown in the following three examples.

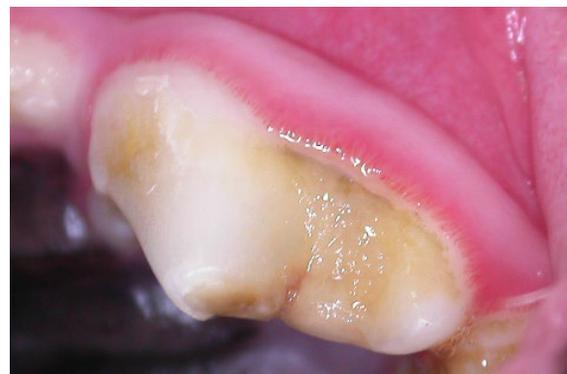
Not much damage to the crown or anything visually to suggest endodontic disease...

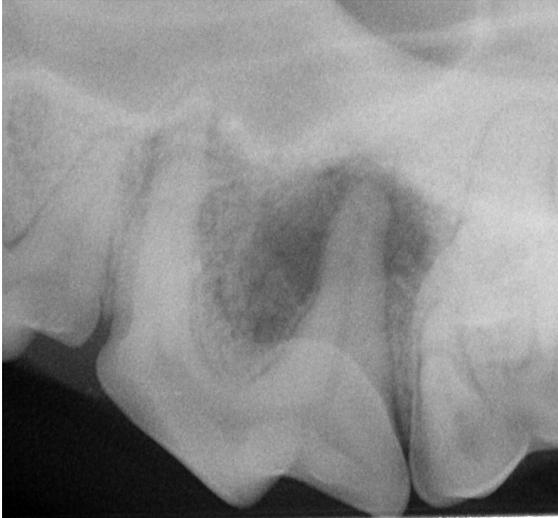
...but radiographically, there is massive bone loss around all three root tips indicating chronic infection.

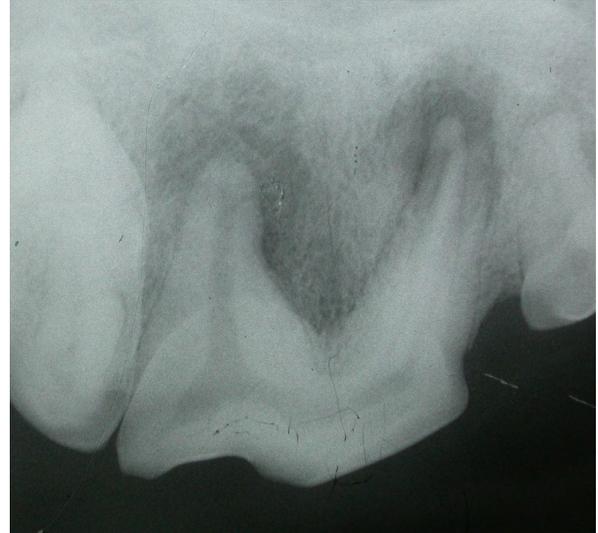
...but radiographically, lots of apical bone loss.

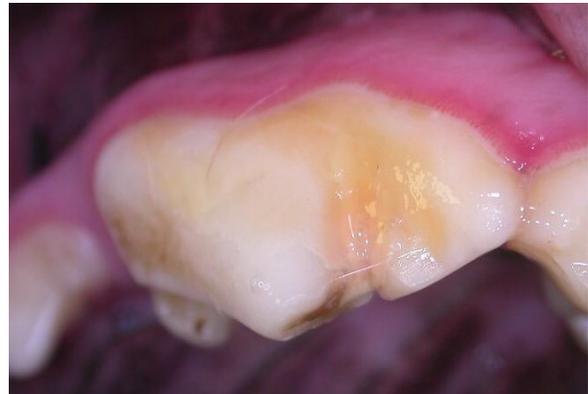
And finally, here is the left upper 4th premolar of a 5.5-year-old golden retriever with very superficial damage...

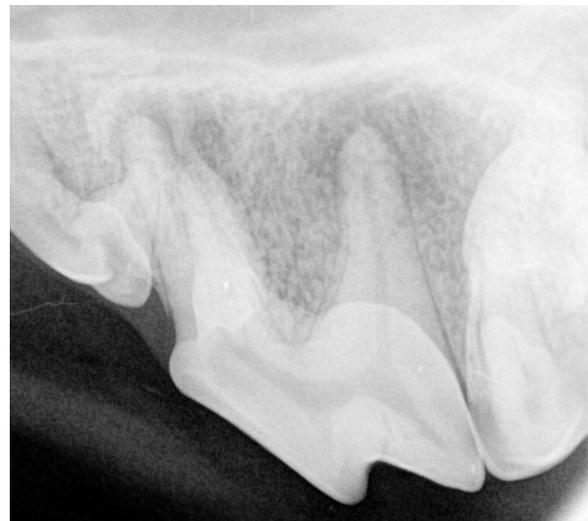
...but very obviously the victim of septic pulp necrosis and chronic periapical periodontitis.

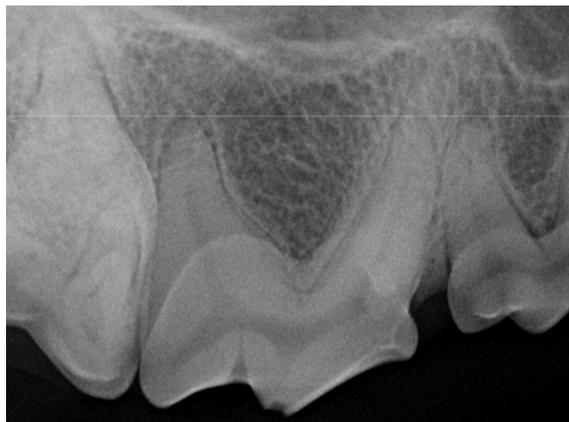
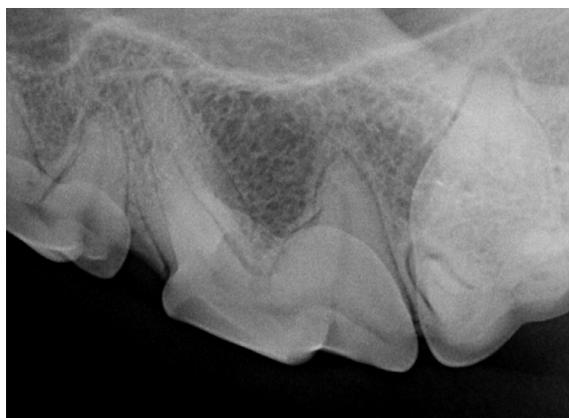
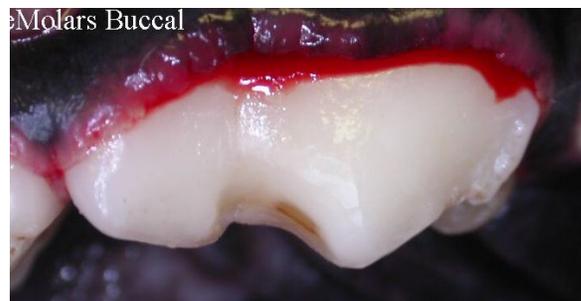
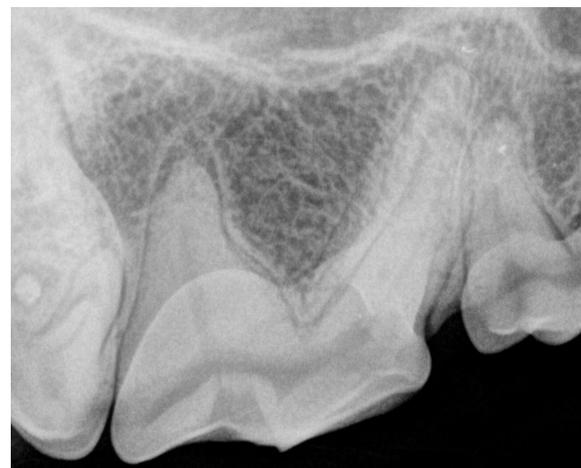
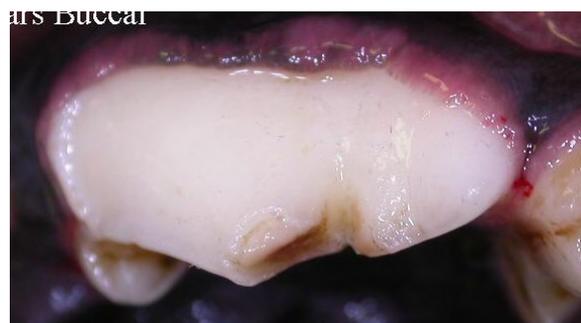
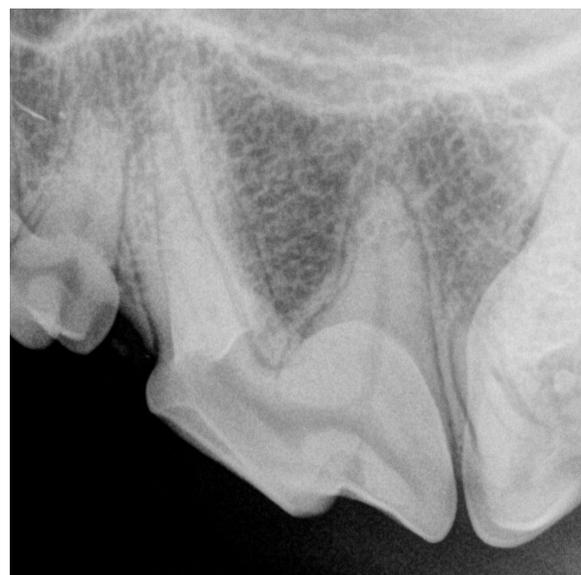
And I could find no clinical or radiographic evidence of endodontic disease at that time. The transillumination suggested blood flow through the crown of the tooth meaning the pulp was alive then, but this does not mean it was healthy. There was insufficient evidence of pulp pathology to warrant extraction or root canal treatment at that time, but this is no guarantee that endodontic disease would not develop in the future. So, treatment involved a thorough oral hygiene procedure followed by coating the fracture sites with a fluoride-releasing bonding agent to seal the exposed dentin tubules and offer some protection for the underlying pulp tissue. Then we planned to see Breeze again a year or so later for follow-up.

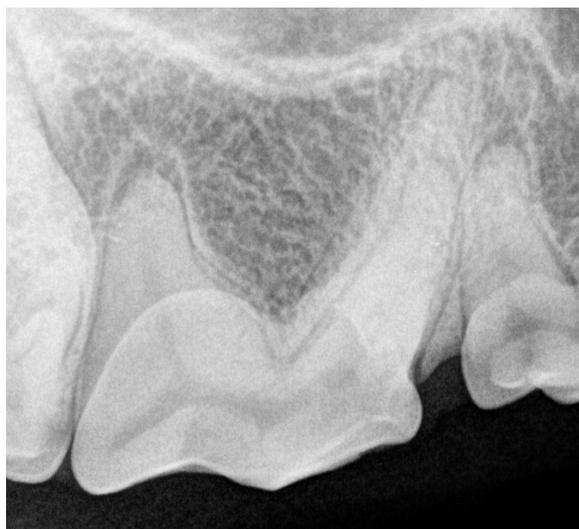
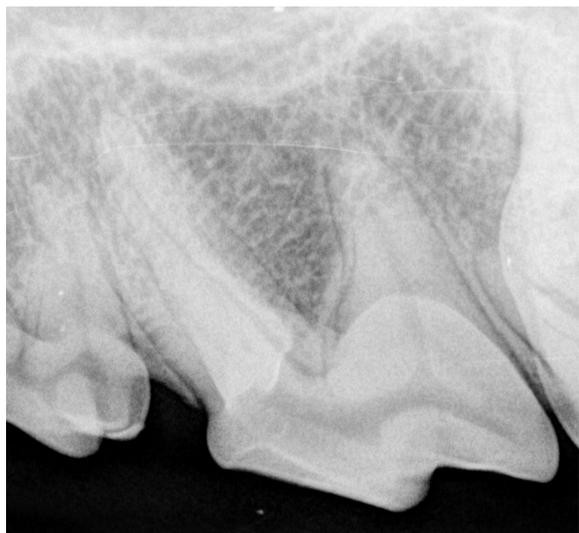
Radiographically, I think they are still doing well.

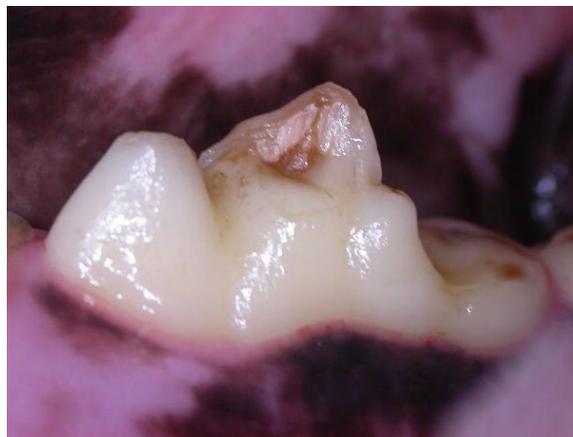
Here is a pre-op photograph from the lingual aspect showing a significant uncomplicated crown fracture. Fortunately, I had prior year's radiographs as a baseline and here they are. The first is from October, 2008 and the second from March 2010.

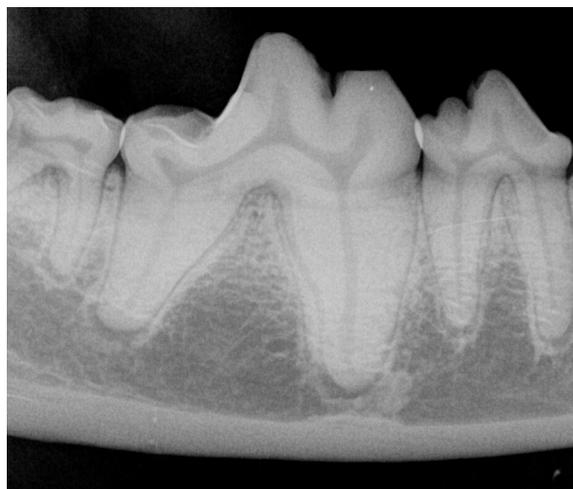
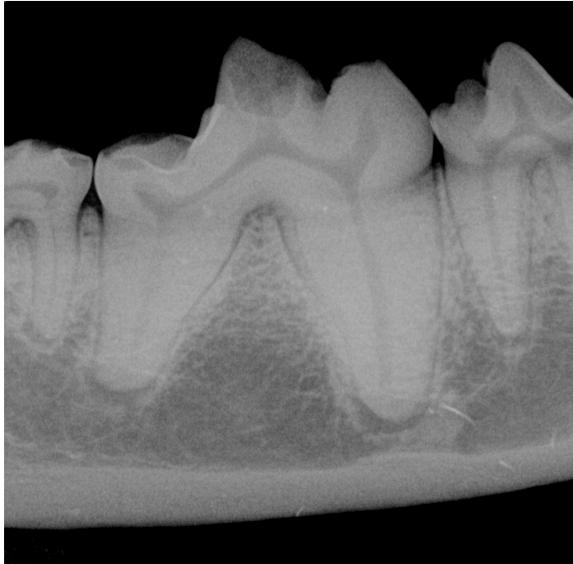
In those images we can confirm that there was no significant damage to the crown of the tooth at prior visits and that the chevron signs have been there and unchanged for some years (ie normal for this dog). Even the little density mesial to the tip of the mesial root has been there for a long time without change (again, likely of no significance). Below is this year's radiograph showing the obvious coronal damage but otherwise, no changes to indicate endodontic disease.

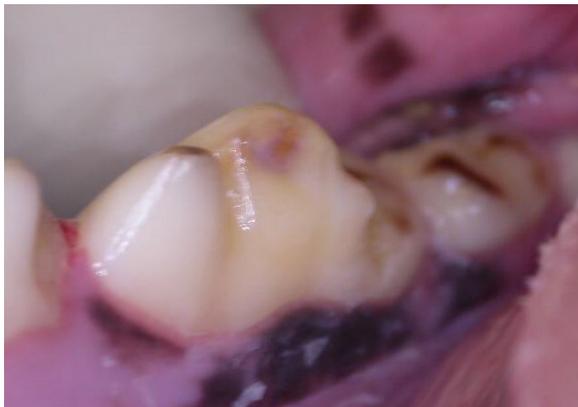
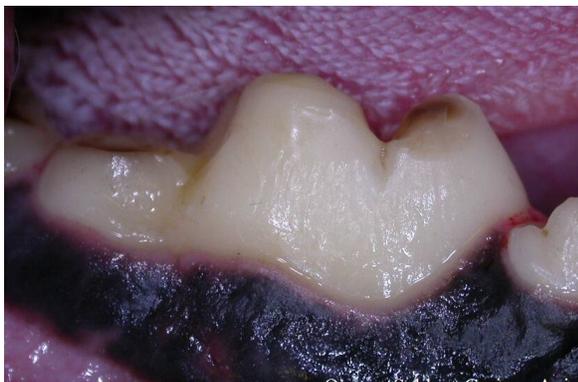
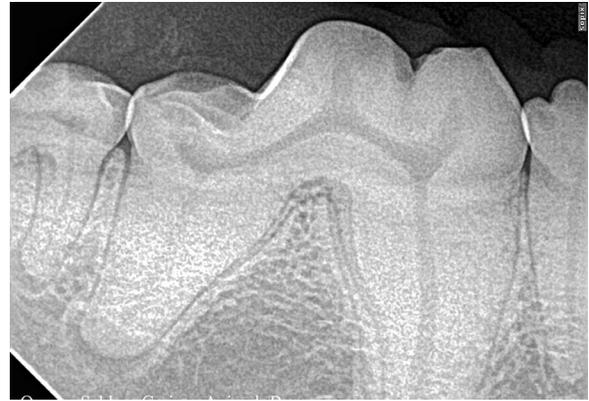
I was worried about the tall, thin spike of the central cusp being a weak point and prone to further fracture so I did some odontoplasty to create a mechanically more sound profile to the crown of the tooth and then sealed the exposed dentin with a bonded resin as shown in the following images.

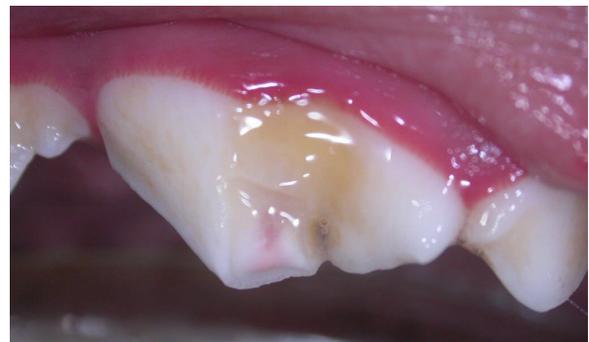
In another case, a 1.5-year-old Australian kelpie was presented with an uncomplicated crown fracture of the left upper 4th premolar in which the evidence was that the pulp was alive but that the fracture was so close to the pulp (near pulp exposure) that it would likely not survive much longer without treatment.

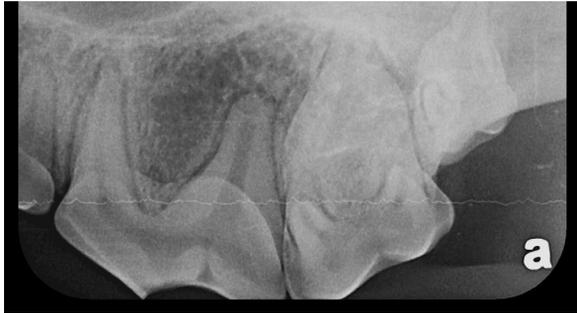
Simply putting a bonding agent on the exposed dentin was not going to be enough protection for this tooth. And any solid restoration I might have bonded over the area as a bandage would have popped off within weeks. Restorations can do well in holes when surrounded by tooth tissue but do not last well in a dog mouth when simply glued on to an exposed surface. On the other hand, it was an immature tooth with vital pulp.

The immaturity meant (among other things) that the pulp chamber would be large and the wall of the tooth thin.

I did not want to extract this tooth, I did not want to do root canal (total pulpectomy) on this tooth and I could not protect the pulp by gluing a restoration on to the exposed fracture site, so I did vital pulp therapy. I have done this procedure many times on single-root canine teeth but not often in multirooted teeth. None-the-less, it seemed the best option in this case and so we proceeded.

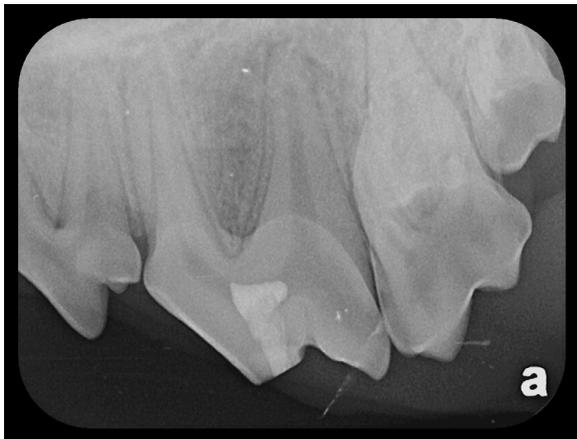
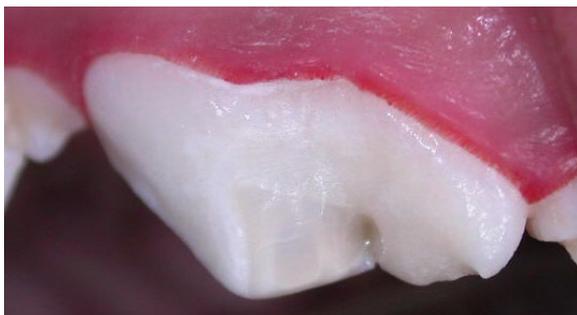
The images above were taken immediately post-op. The images in the next column were taken at follow-up eight months later.

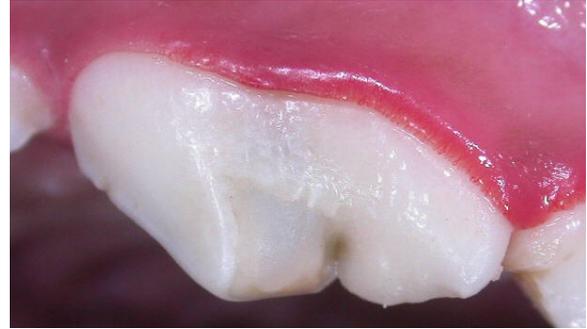
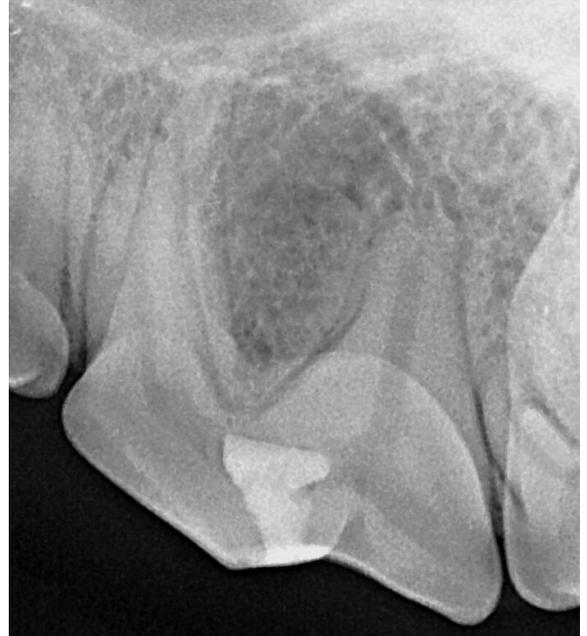
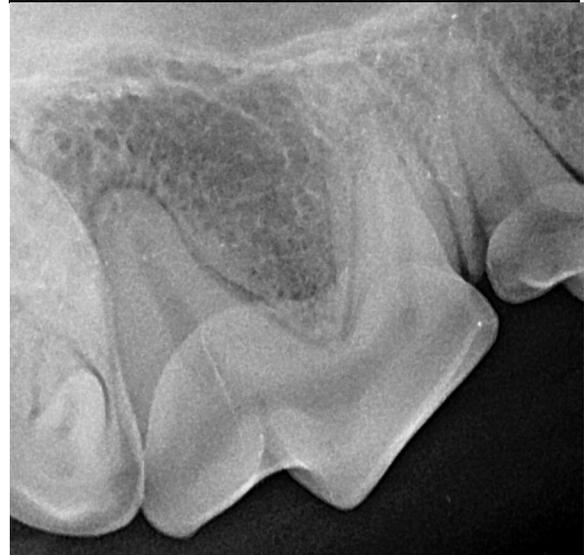
The pulp chambers are smaller than pre-op, the same size as the right 4th premolar and there are dentin bridges adjacent to the pulp capping material. As well, the tooth transilluminated well and there are no signs or periapical changes. All

indications are that the tooth survived the injury and the treatment and should do well in the long-run, providing the dog does no further damage to it.
